# MARYSVILLE JOINT UNIFIED SCHOOL DISTRICT FACILITY MASTER PLAN

AUGUST 2022

PBK Architects, Inc.

# FACILITY CONDITION ASSESSMENT 2022

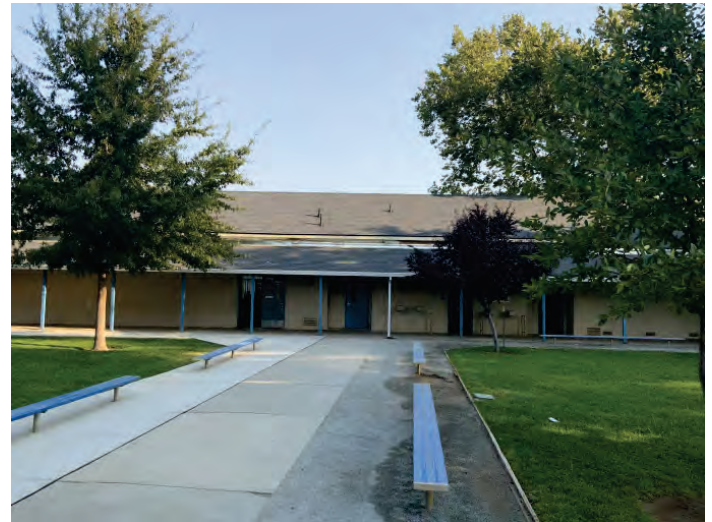
The site is overall in good condition and meets the needs of the students. There is a good amount of hardscape; introducing more planters would be beneficial.

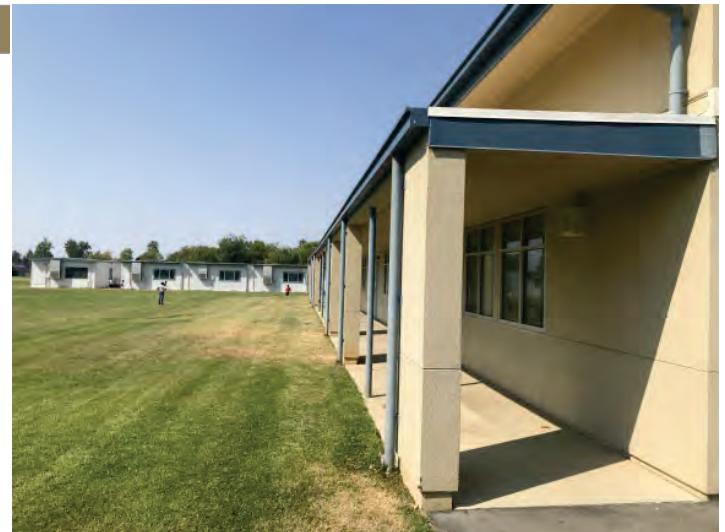
The site overall is in good condition, well maintained, and the parking lot and path of travel to the building appear to be in good condition and code compliant. The roadways could use a seal coat in the near future.

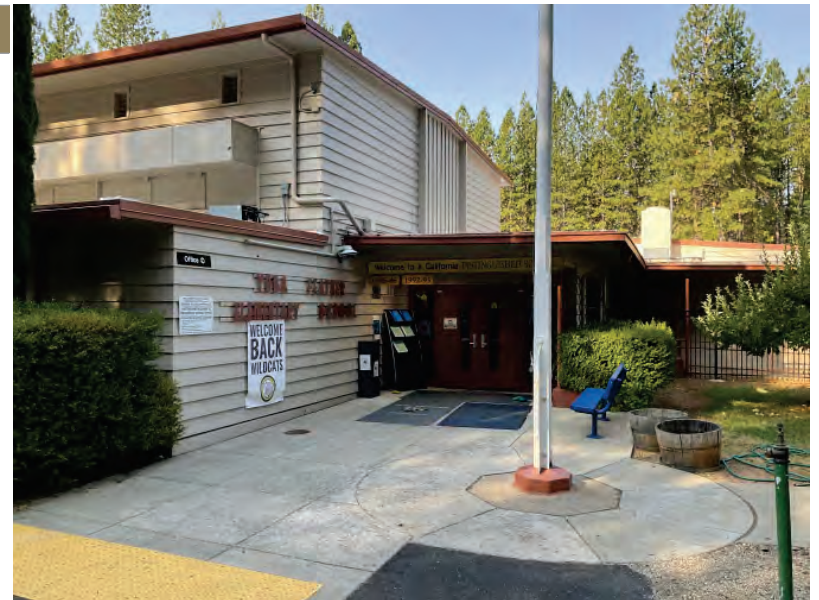
The site is in good condition. Ramps down to lower play fields appear to be compliant and well maintained. The front parking lot is sloped, consequently accessible parking is out of compliance with current building code regulations.

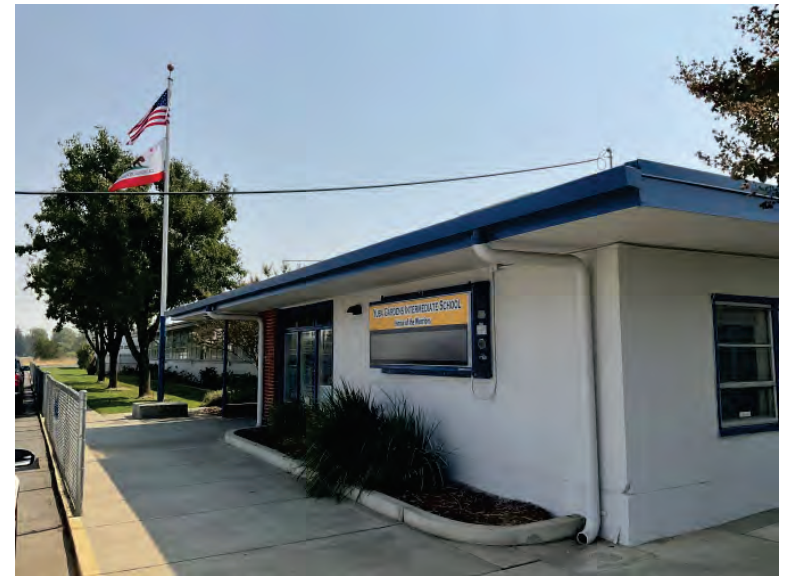
The parking lot does not have accessible parking nor a code-compliant drop-off area. The driveway paving and the playfields appear to have ponding issues. Building signage is non-existent and room signage appears to be non-code-compliant.

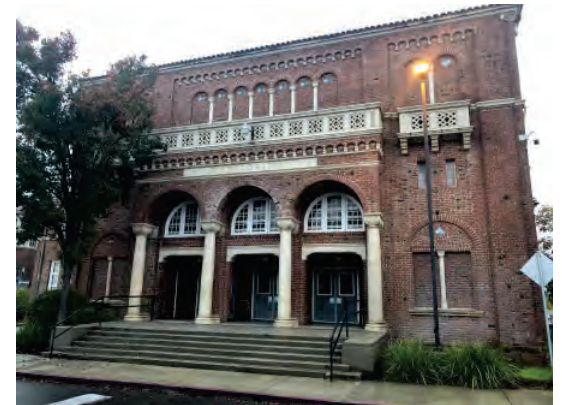
The site at around these buildings is typically limited to parking lots and driveways between the Facilities buildings. Accessible parking and building signage is provided sporadically at best. Drive paths are asphalt paving; seal coating is recommended to extend their useful life.
